This spreadsheet performs screening level calculations to estimate the effect of peeling leaded paint on the average concentration of lead in yard soil  
**3714 Marion Street**

Property No. **512**

Address: **3714 MARION ST** Date: **6-28-05**

Property # 512 / 3714 Marion St.

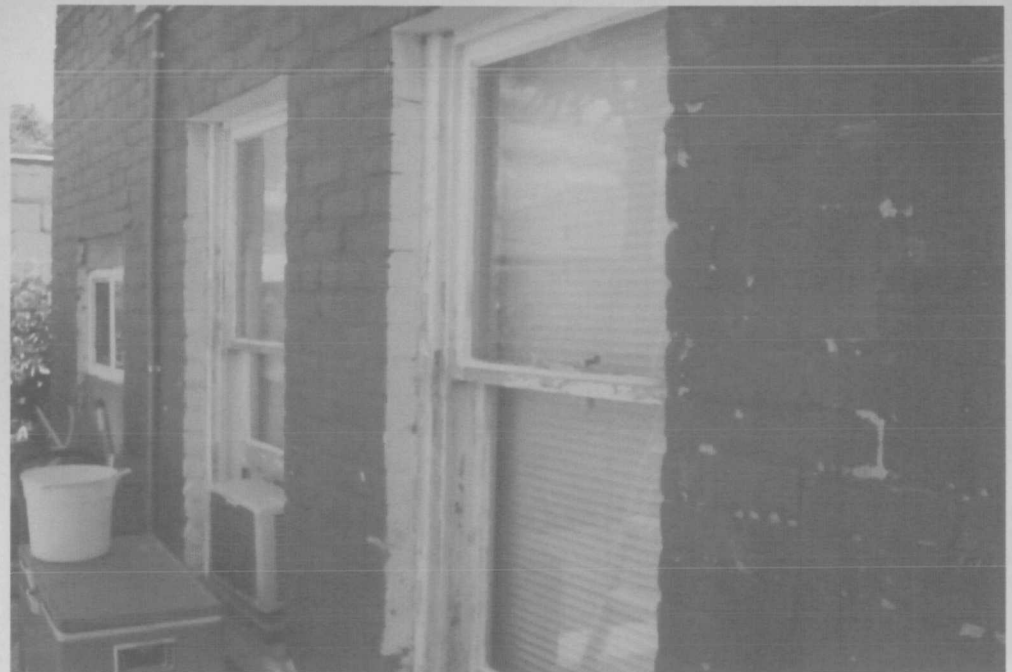
| INPUTS | | | |
|---|---|---|---|
| | Incremental concentration | mg/kg | 136.5 |
| <b>DECISION</b> | | | OK |

| Metal Trim/Gutters/Downspouts | | | | Misc Structures/Garage/Fences | | | |
|---|---|---|---|---|---|---|---|
| North | | | | WOOD TRIM | 12' $\pi$ | PEEL | 10.4 |

White wood window trim on garage contains lead paint
